Short shifter

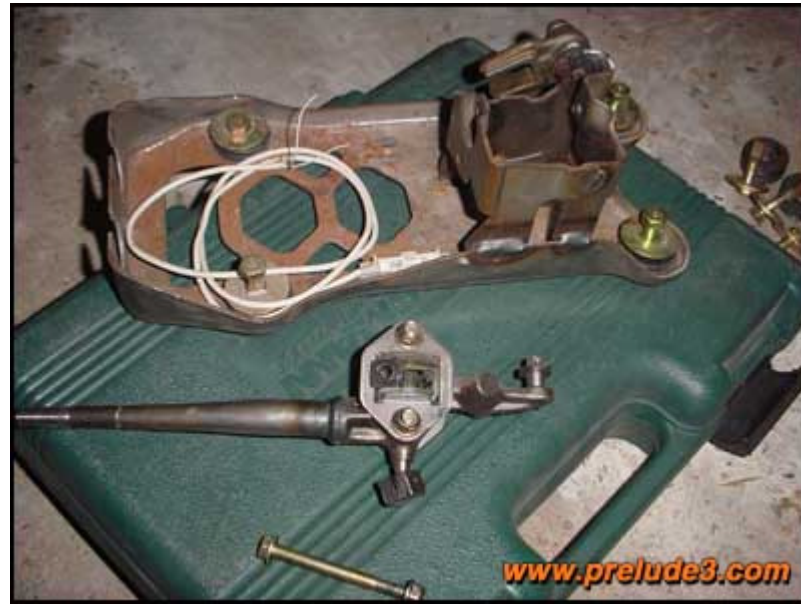
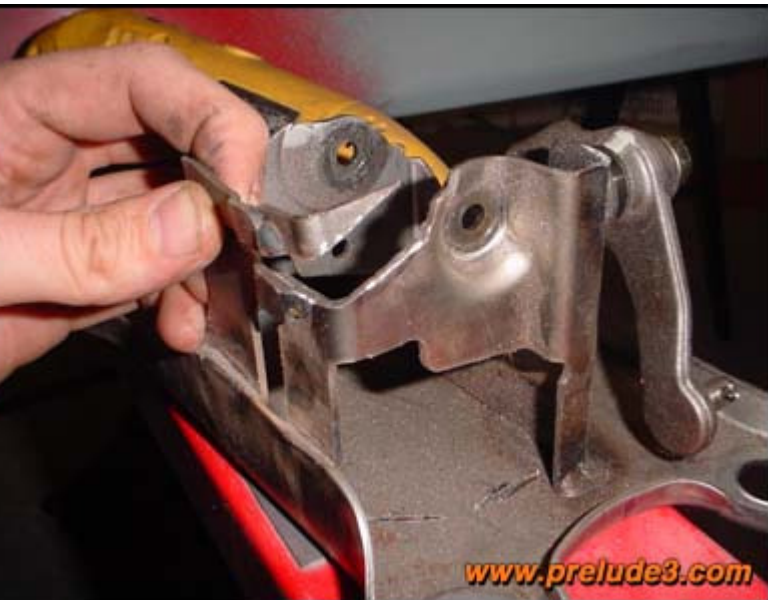
To be able to shift faster, you have to swap the stock shifter for a short one. On a short shifter, the top of the shift lever is shortened, while the part being under the pivoting point is extended. For many cars a short shifter is available, but unfortunately not for the third generation Prelude. So make it yourself! Pictured is one unmodified and disassembled.

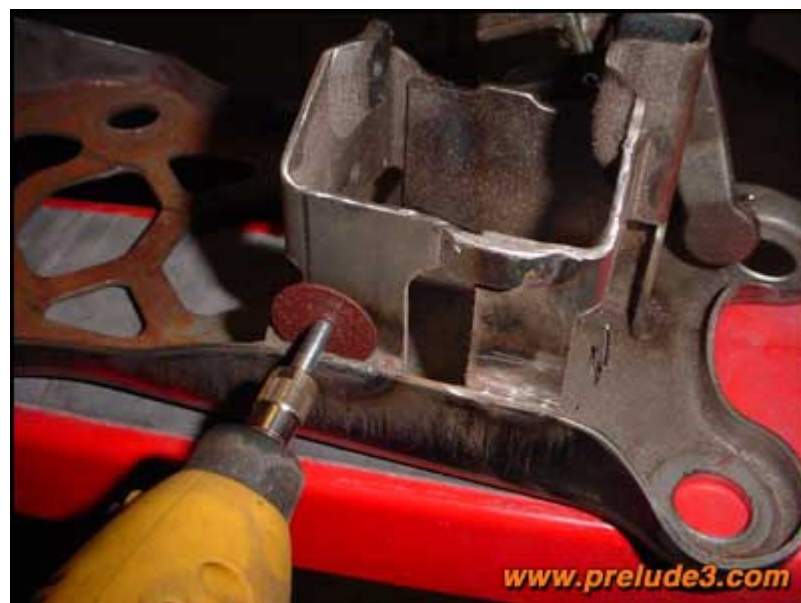
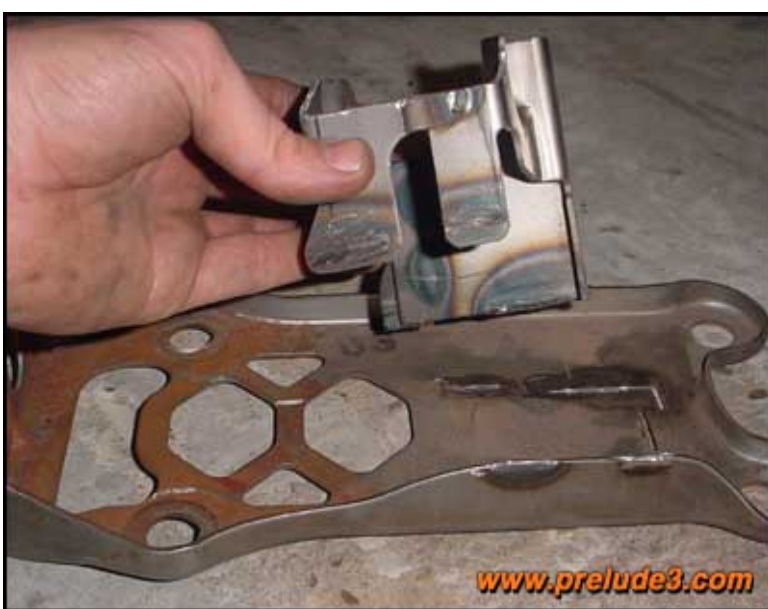
.With a Dremel tool I cut the welds of the bracket. I try to cut the welds only for the bracket to remain intact.

After cutting all welds, the bracket is detached from the frame.

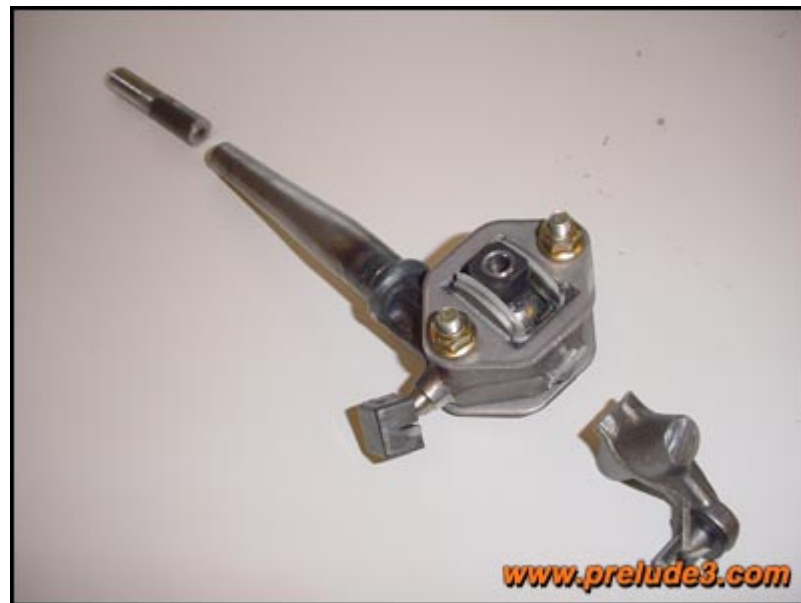
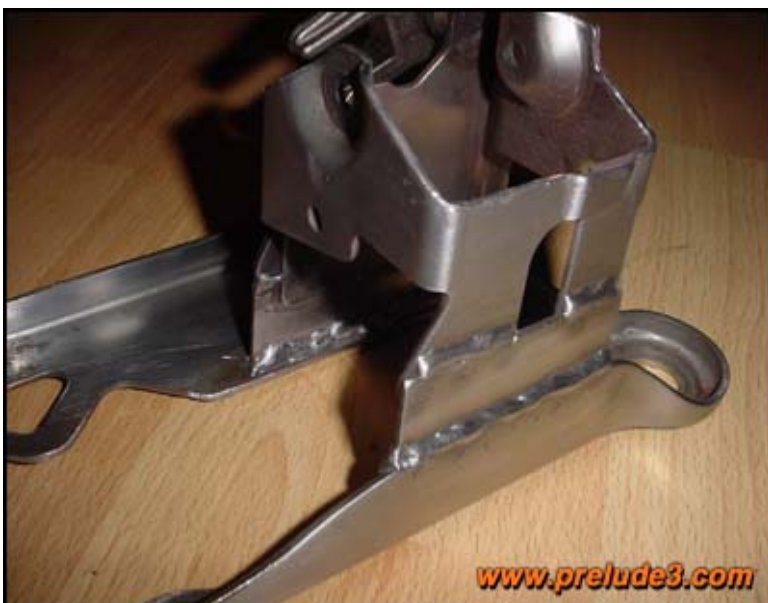
Here I cut off the upper and lower part of the shift lever. The cut off piece of the upper part will be used to extend the lower part. New thread will be created on the shortened upper portion of the lever.

The bracket is raised two centimeters by welding in two metal plates on both sides.

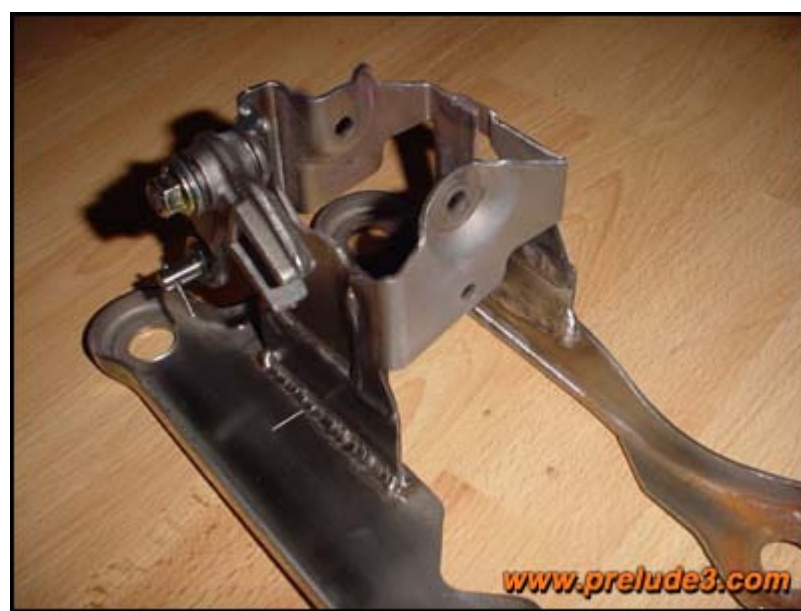
You can see that a part of the frame was cut out. I did this, because the bracket was raised by two centimeters, while the lever was extended downward by 2.5 centimeters. So the distance between the lever and the shifter frame was decreased by 0.5 centimeters. This would cause problems because the shifter cables will interfere with the frame. This problem is dealt with by cutting out the portion of the frame beneath the shifter cables, as there's some space between the frame and the chassis of the car.

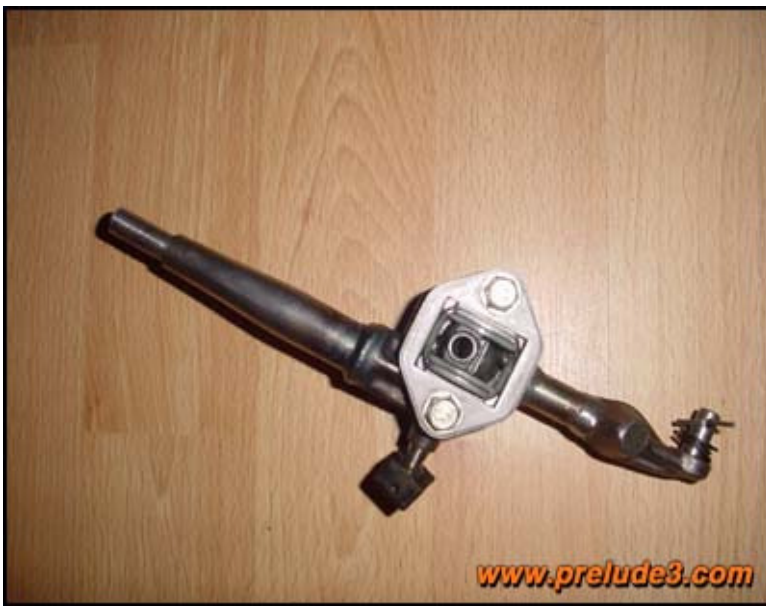
This is the modified shift lever. The top is rethreaded and the bottom is extended by 2.5 centimeters, by welding in between a piece of the cut-off top.

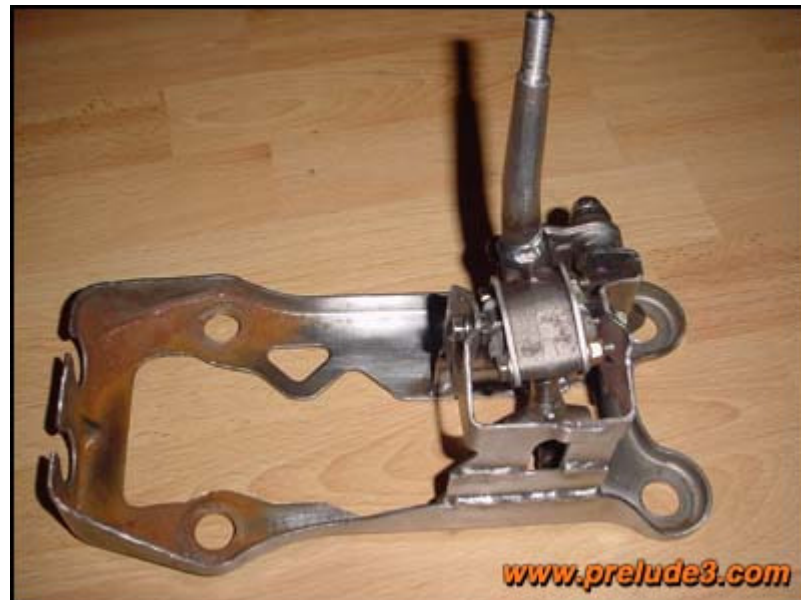
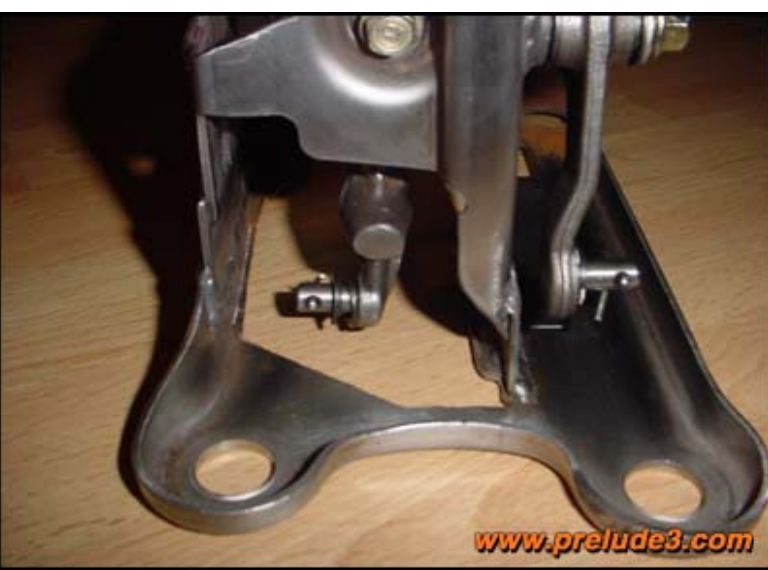
The short shifter reassembled.

Clearly visible here is the hammer-like thingy located on the shift lever. It ensures that the lever cannot be pushed forward or backward too far, so that the ball joint operating the lever in the bracket isn't stressed too much.

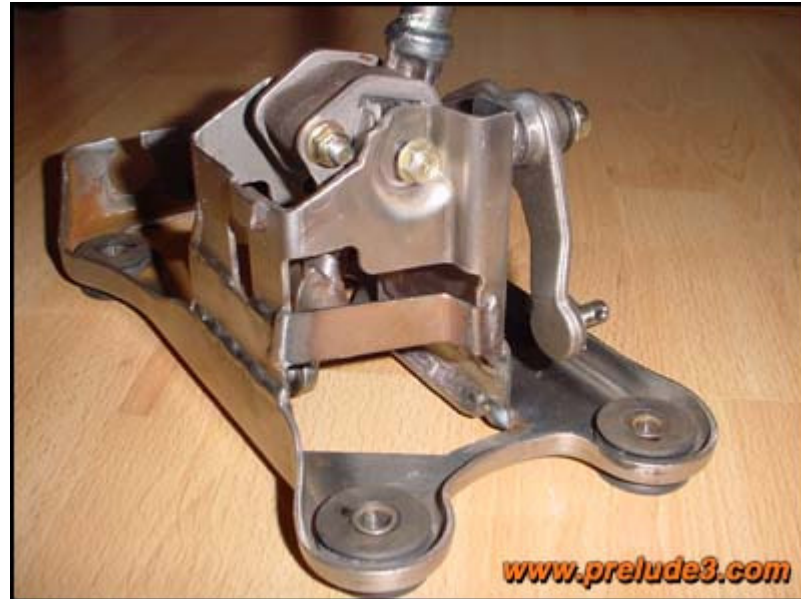
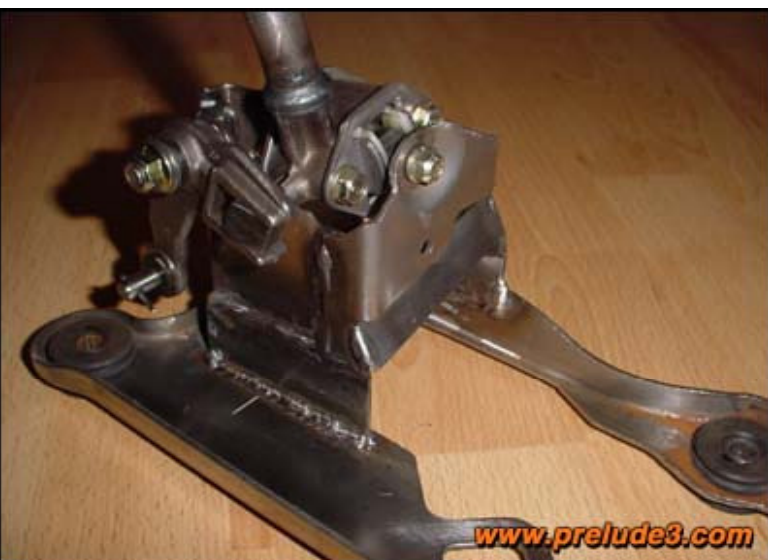
Because the bottom of the shift lever was extended, the hammer-like device is located lower now, not touching the front and rear of the bracket anymore. So now there's no longer a 'bump stop'. By welding an extra metal plate to both the front and rear of the bracket, that problem has been solved as well.

The extra metal plate on the front.
